# Geographical Study of the Disaster in Japan and the activities of "Commission of Disaster Responses" of the Association of Japanese Geographers

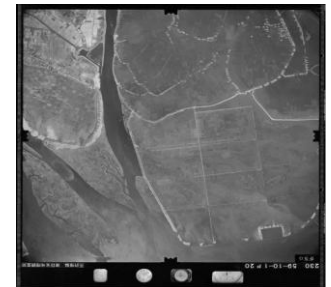
Fig. 4 Air photo along the coast of Ise Bay after Isewan Typhoon of 1959  
The photo was taken by GSI

Isewan Typhoon (Typhoon *Vera*) of 1959 brought the biggest damage caused by flood in Japanese modern history (Fig. 4). More than 5,000 people were killed or missing by it. The main damaging phenomenon was the high tide invading into Nagoya city and its surroundings, southern part of Nobi Plain. Three years before the disaster, geographer OYA Masahiko made a 1:50,000 geomorphological map on Nobi Plain (Oya 1956) (Fig. 5). The damage area was in accordance with the map which was based on geomorphic features. After this, it became well-known that the geomorphological mapping is effective for understanding the flood risks, and the Geographical Survey Institute (present name: the Geospatial Information Authority of Japan; GSI) of the government started a project to prepare the "1:25,000 Land Condition Maps," which show geomorphic feature and facilities for disaster measures of the plain area in 1960 (Fig. 6).

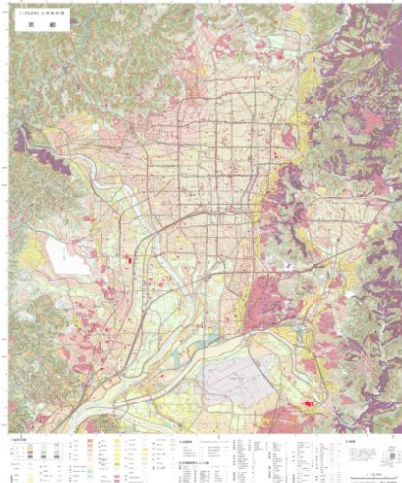
Fig. 6 Land condition map of "Kyoto" published by GSI  
[http://www.gsi.go.jp/bousaichiri/c\\_index.html](http://www.gsi.go.jp/bousaichiri/c_index.html)

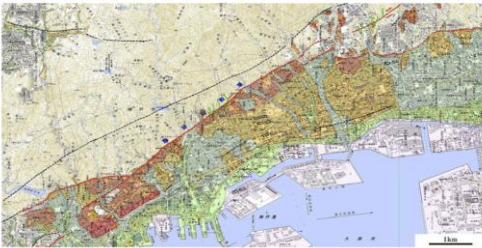
Fig. 9 Active fault map of the urban area of Kobe (presented by Geospatial Information Authority of Japan)

The 1995 Southern Hyogo Prefecture Earthquake caused by an intraplate fault activity hit Kobe city and its surroundings, one of the highly-urbanized areas in Japan (Figs 9 and 10). Before the earthquake, geomorphologists and geologists had made an active fault catalog in Japan (Research Group for Active Faults of Japan 1980, 1991) and it paid considerable attention to the occurrence of the earthquake. After the earthquake, the government established the Headquarters for Earthquake Research Promotion (HERP). The "National Seismic Hazard Map," which shows the probability of great earthquake motion, has been open to public by HERP.<sup>2</sup> Many tectonic geomorphologists cooperated with this project (Ota and Okumura 1999, Kumaki 1999).

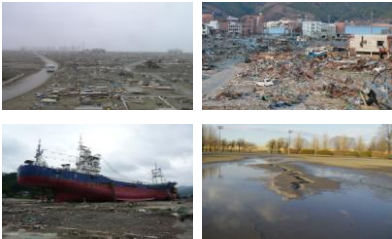
Fig. 12 Disasters caused by the 2011 off the Pacific Coast of Tohoku Earthquake. (a) Natori city located at the Sendai coastal plain (by K. Hori). (b) Onagawa town located at ria coast (by S. Ishiguro). (c) Vessel beached on the shore (by C. Oguchi) (d) Liquefaction at a park of Tochigi city located far from the epicenter (by Tochigi city employee).

On March 11, 2011 the off the Pacific Coast of Tohoku Earthquake occurred (Fig. 12). It caused a huge tsunami and more than 19,000 people were dead or missing. This catastrophic disaster including an accident of the Fukushima Daiichi Nuclear Power Station is called the Great East Japan Earthquake Disaster. The AJG coped with the disaster by the special system. The headquarters for disaster response was set up and YAGASAKI Noritaka, the chairperson of the executive committee of AJG, took office as the general manager. It performed liaison with other academic societies, information dispatch through website<sup>5</sup>, etc. until April, 2012.

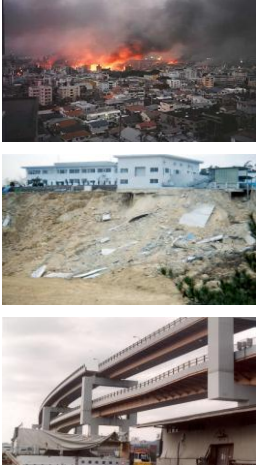
Fig. 10 Disasters caused by the 1995 Southern Hyogo Prefecture Earthquake. (a) Fire in Kobe city (by I. Kobayashi). (b) Slope failure (by T. Kuroki), and (c) Damaged express highway (by T. Kuroki).
